NATIONAL PROGRAM FOR INSPECTION OF NON-FEDERAL DAMS
UPPER SHEPAUG RESERVOIR (U) CORPS OF ENGINEERS WALTHAM
MA NEW ENGLAND DIV MAY 79

NATIONAL DAM INSPECTION PROGRAM
PHASE I INSPECTION REPORT

NATIONAL PROGRAM OF INSPECTION
 OF NON-FED DAMS
**UPPER SHEPAUG
 RESERVOIR DAM**

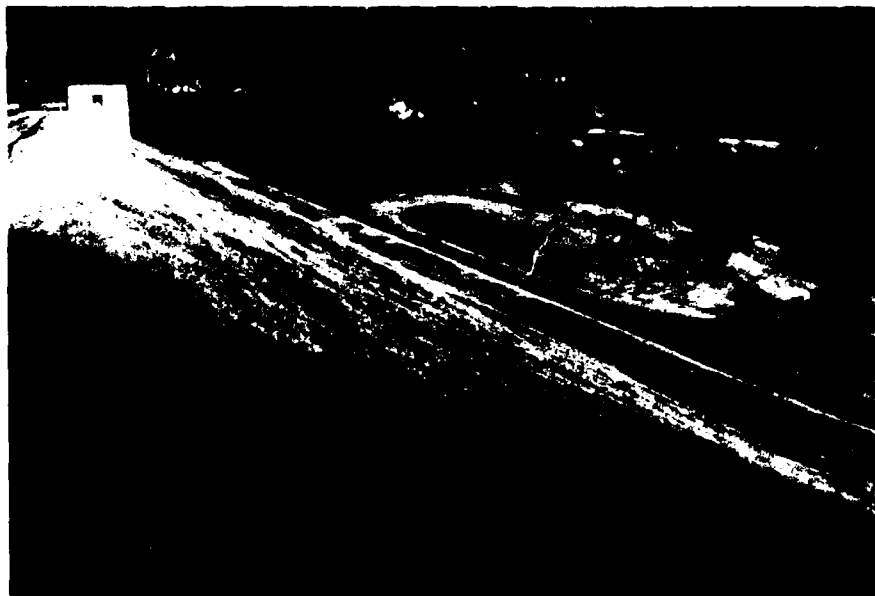
c. Appurtenant Structures. Visual inspection of the concrete spillway, spillway channel, and outlet works did not reveal any evidence of stability problems. The concrete surface and construction joints appeared to be in good condition with the exception of occasional cracks and seepage in the spillway discharge channel as seen in Photo 9.

The spillway discharge channel is in good condition with the exception of occasional cracks and seeps as shown in Photo 9.

(3) Cracks and seepage in the concrete spillway discharge channel.

PHOTO NO. 9
Crack in spill-
way training
wall, right (west)
side, approxi-
mately 100'
downstream
from crest.
